# AxFlow restores obsolete Trimax pumps

An urgent call was received by Axflow from a customer with a breakdown of a fifty year old extruder pump, which made busbars. Busbars are essential components within power transmission systems and traditionally are made from copper because this material delivers high levels of conductivity. However, it is not the lightest of materials nor is it the cheapest. Where weight and cost are critical factors in applications such as electrical power distribution, renewable energy, electrical inverters and components for the aerospace, railway and marine industries, solid copper busbars are not the ideal solution.

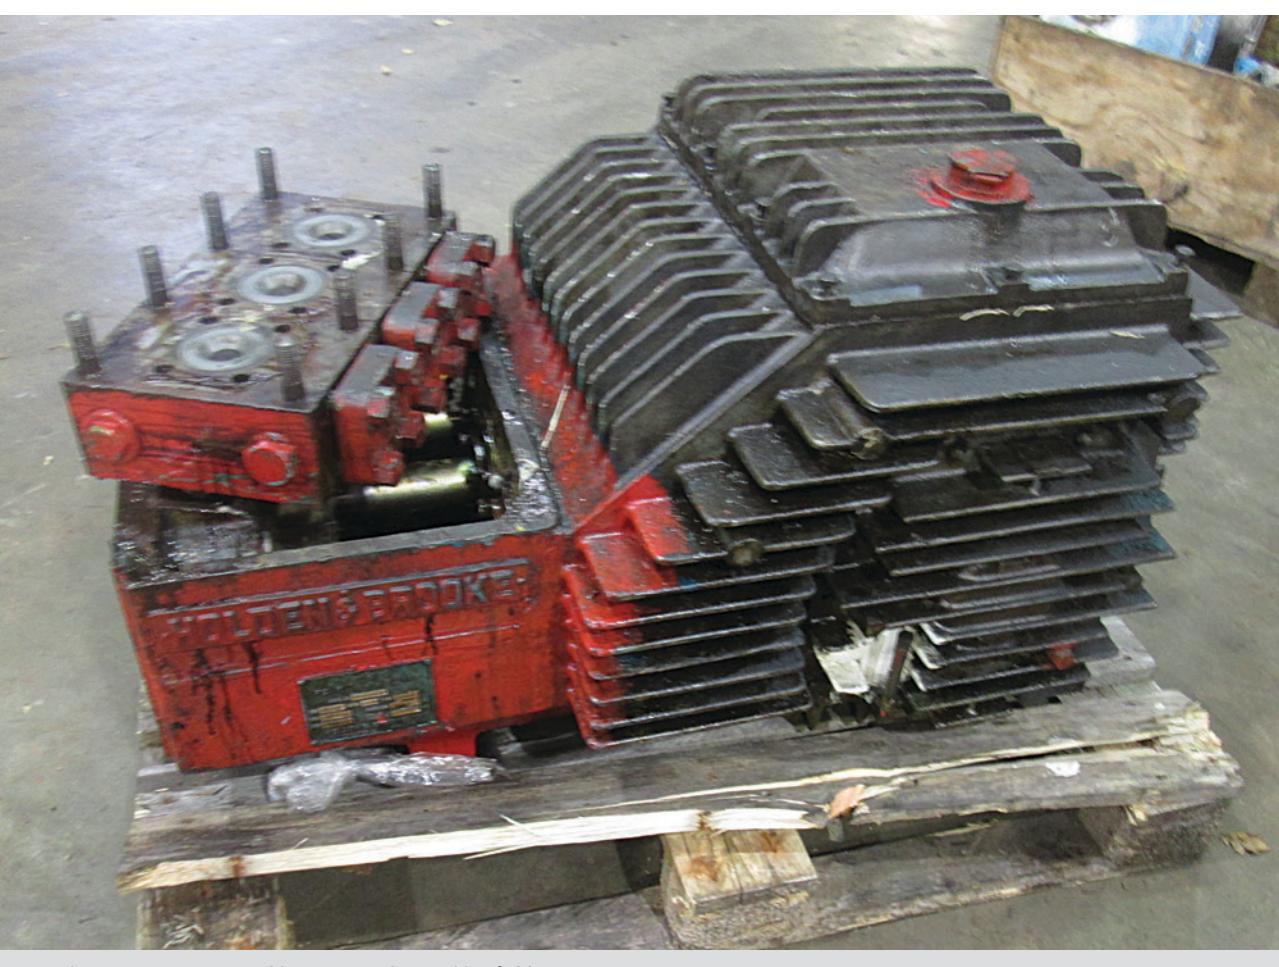
Fig 1. The Trimax pump assembly as received at Huddersfield.

Just how critical the pump's performance is to the extrusion process became very clear when the No 1 pump suffered a catastrophic failure. This may have been caused by a closed discharge valve in the system (Fig. 1). Fortunately, the process system included a second pump, enabling production to continue. Replacing the damaged pump was deemed a priority as two pumps provide system resilience, but this was far from being straightforward. The Holden & Brooke Triplex pump was obsolete.

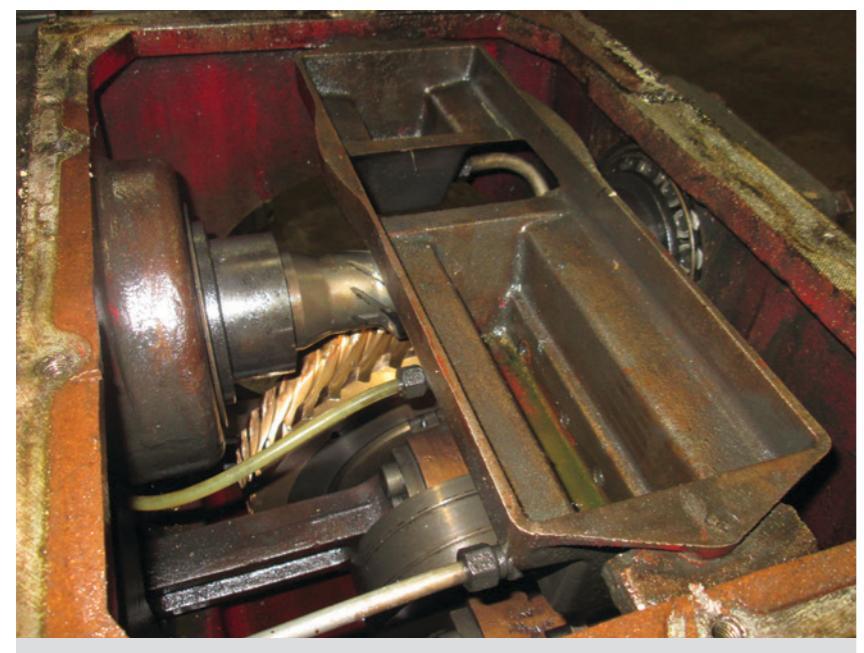
Fig 2. The pump internals were badly worn.

Huddersfield Service Base being called in for advice. "We responded to Hydrostatic Extrusions' enquiry by despatching one of our Scottish-based sales engineers to take a look at the pump and prepare a report," explains Tom Cooper, AxFlow Service Base Manager. "It was in a very poor state of repair (Fig. 2) and needed some serious work if it was to re-enter service and perform to the customer's requirements. However, we considered that extensive repair work, which included making completely new components, was possible. We prepared a full report supported by extensive photographs, the associated costs and a timeframe in which the work would be carried out, and this was accepted by the customer."

The report identified many key failings, the crankshaft had sheared, causing excessive force on the bearing housing resulting in the casting cracking. Both items had to be completely replaced. In addition, the pinion wheel was damaged so the pinion wheel and worm shaft had to be replaced as a

pair (Fig.3). The conrod bearings were badly worn and had to be replaced. One of the crankshaft bearings was seized on to the crankshaft meaning that both the crankshaft and the bearing had to be replaced. AxFlow's final recommendation was to replace all the seals, packings and gaskets as well as the taper roller timken bearings for the worm shaft.

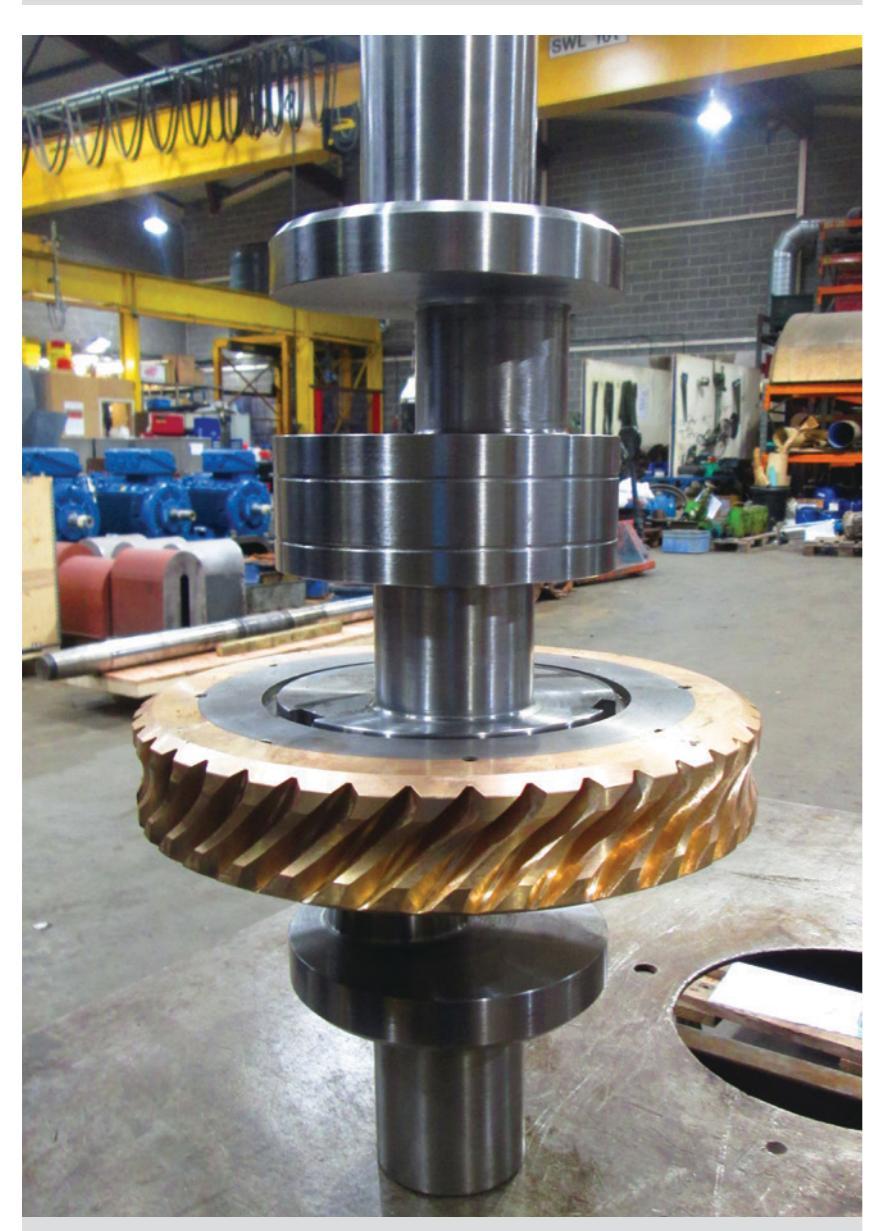
Fig 3. A new pinwheel and worm had to be made.
